# Manhole Inspection Summary

Manhole # S05AA2012MH

Insp Date: **8/17/06 12:00 AM**

**Location** Address: **5909 KEY AVE**

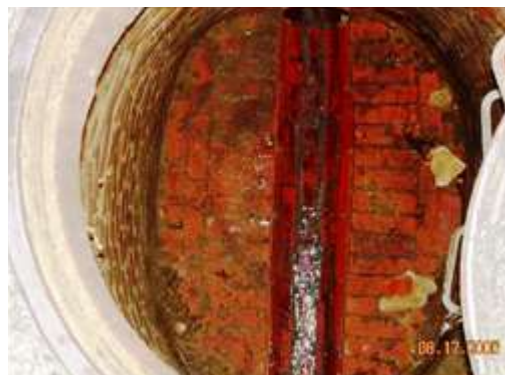
Top View

Frame leaks. Adjustment and Barrel infiltration. Bench debris.

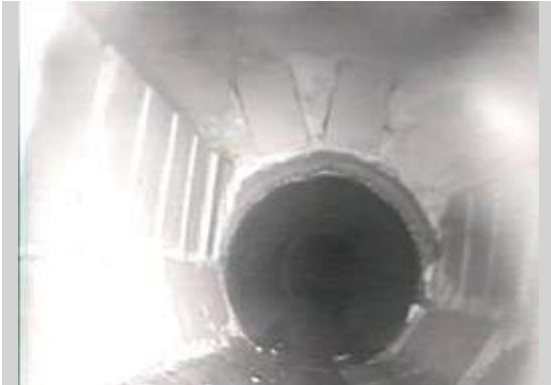
### 8 in. Circular Gravity Sewer Pipe Out @ 12 O'Clock

Infiltration: **Evidence** Pipe Seal Cond: **Unknown**

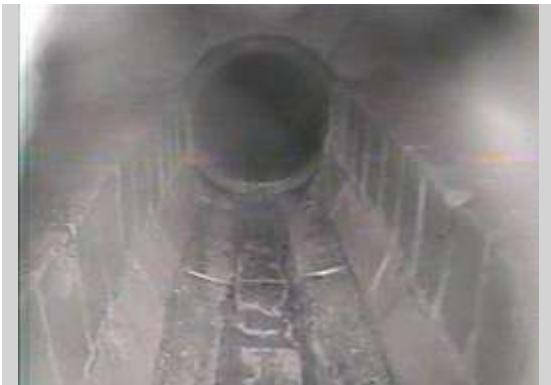
### 8 in. Circular Gravity Sewer Pipe In @ 6 O'Clock

Infiltration: **Evidence** Pipe Seal Cond: **Unknown**
